# 2461 High-Current SourceMeter Instrument

## Version 1.7.16 Firmware Release Notes

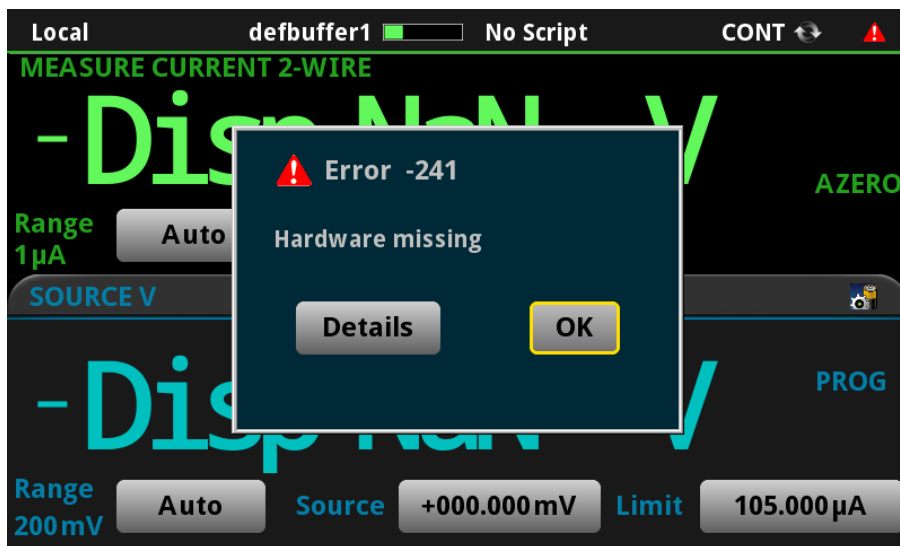
PR61502 From a cold power up, the Model 2461 SMU will sometimes fail with the following error message and will not operate properly.
